156 INCH FIBERGLASS CASE LITVC MOTOR PROGRAM (U)

THIOKOL CHEMICAL CORPORATION WASATCH DIVISION

TECHNICAL REPORT NO. AFRPL-TR-66-331

VOLUME IV APPENDICES

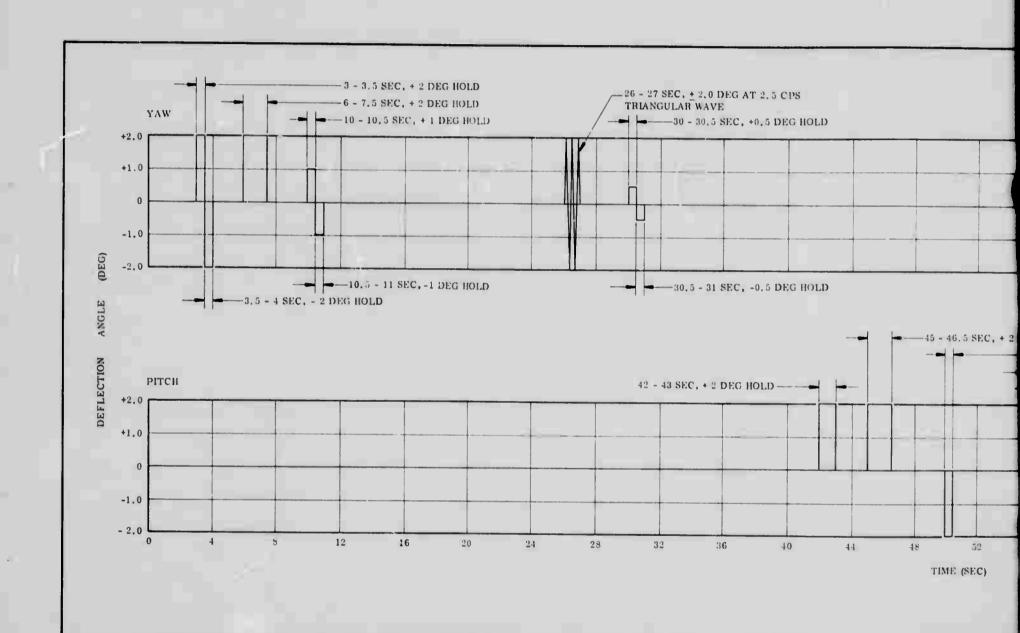
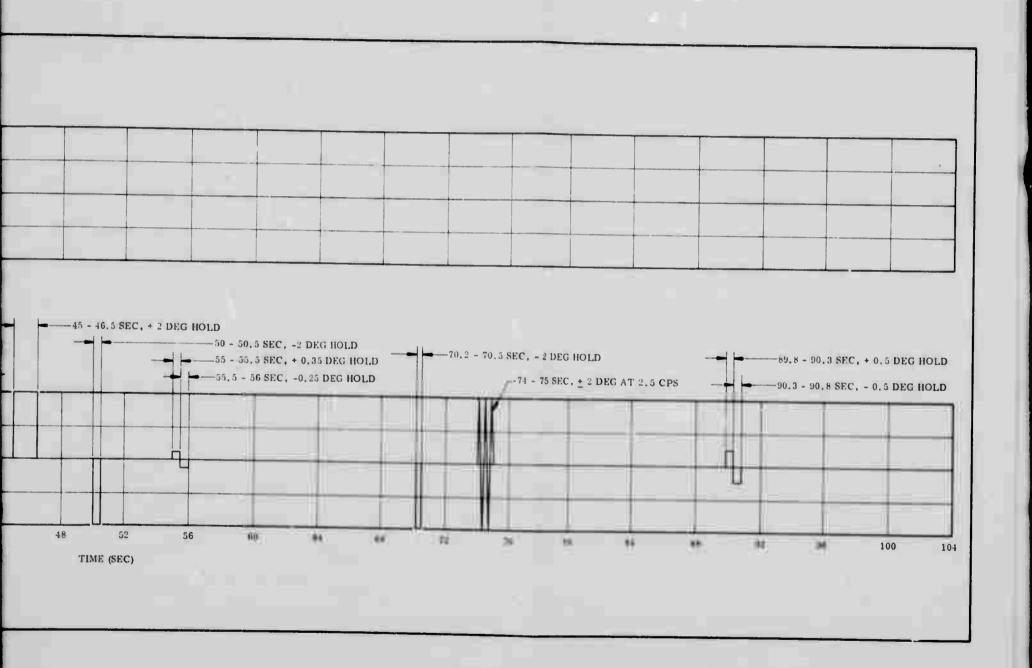
Figure 31. Duty Cycle for Run No. 6

6. RUN NO. 6 - The objective of this run was to determine response to step input commands and to determine static position error. The duty cycle is illustrated in Figure 31.

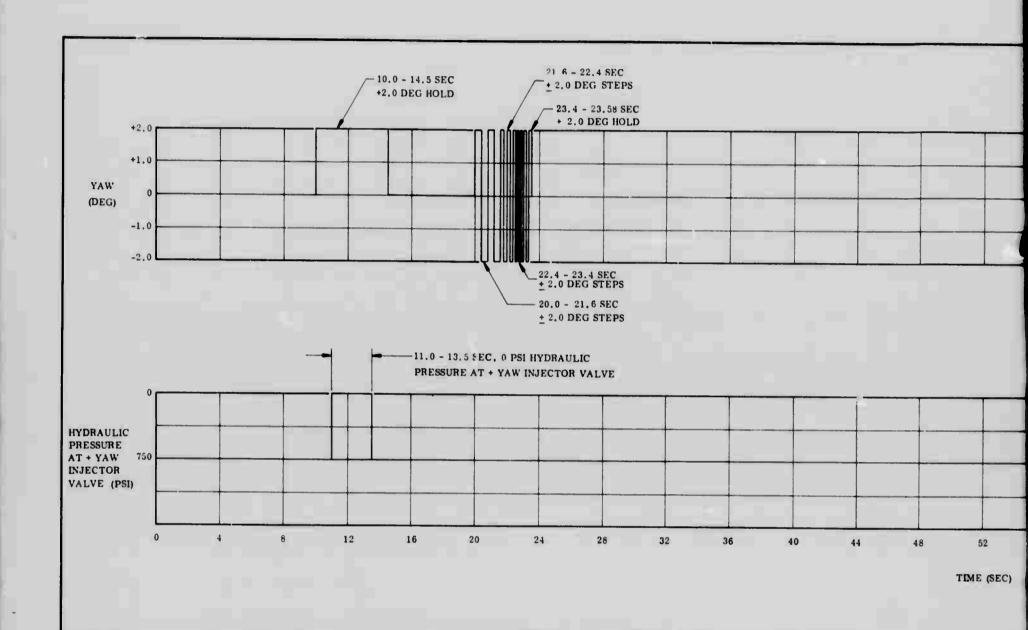
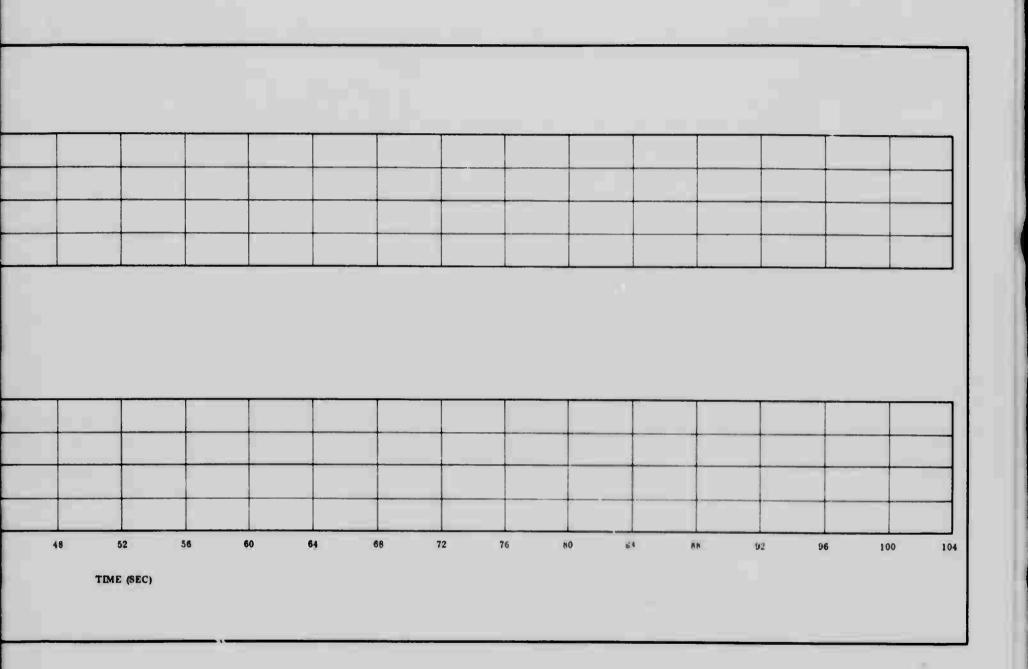
Figure 36. Duty Cycle for Run No. 7
VI-59

7. RUN NO. 7 - This run was conducted to determine the ability of the injector valves to return to the closed position in the event of hydraulic power failure during valve operation. Hydraulic power failure was simulated by venting the supply line and venting the low pressure side of the No. 4 plus yaw injector valve piston simultaneously. See Figure 36 for the duty cycle.

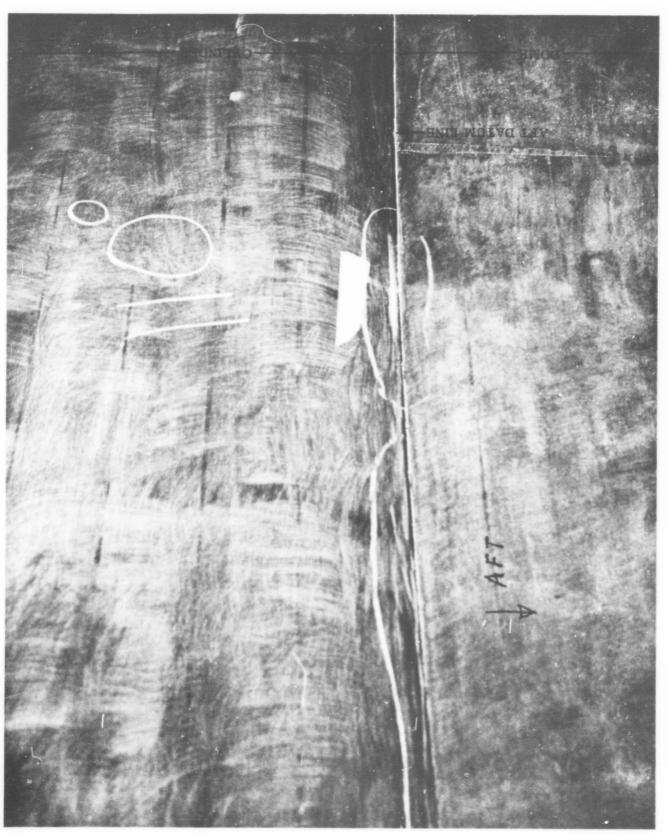
Figure 3. Area of Heat Discoloration

No external evidence of case structure deterioration resulted from the static firing; however, after subsequent hydrobul 'testing, some evidence of overheating was visible on the interior of the case insulation. The area where overheating may have occurred (Figure 3) was located directly above the submerged portion of the nozzle. Upward convective flow of superheated air from the nozzle structure may have intensified the postfiring heat soak in this local area. The condition was not detectable until after the hydroburst test, during which the water (test fluid) cleaned the majority of the char from the case wall.

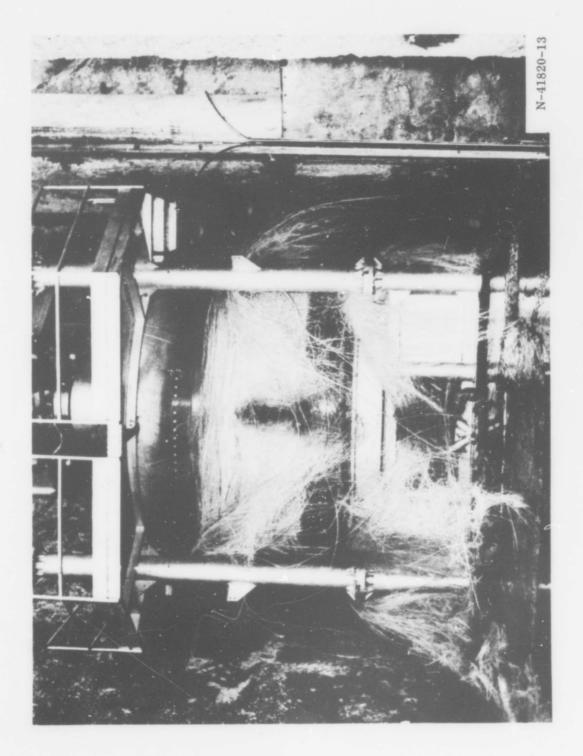
Case failure (Figure 7), which occurred at 963.5 psig, initiated in the hoop windings at the aft datum plane (intersection of the aft skirt with the basic cylindrical section of the case), and progressed forward along the length of the case cylinder. Initial failure occurred at the datum plane and then progressed over the remaining hoop windings on the cylinder. Figure 8 shows the failure sequence.
